WL-TR-91-4032
DOT/FAA/CT-91/23
VOL II, Part 2

COMPOSITE FAILURE ANALYSIS HANDBOOK
VOL II - TECHNICAL HANDBOOK
PART 2 - ATLAS OF FRACTOGRAPHS

R.J. Kar
Northrop Corporation
One Northrop Avenue
Hawthorne, California 90250-3277

February 1992

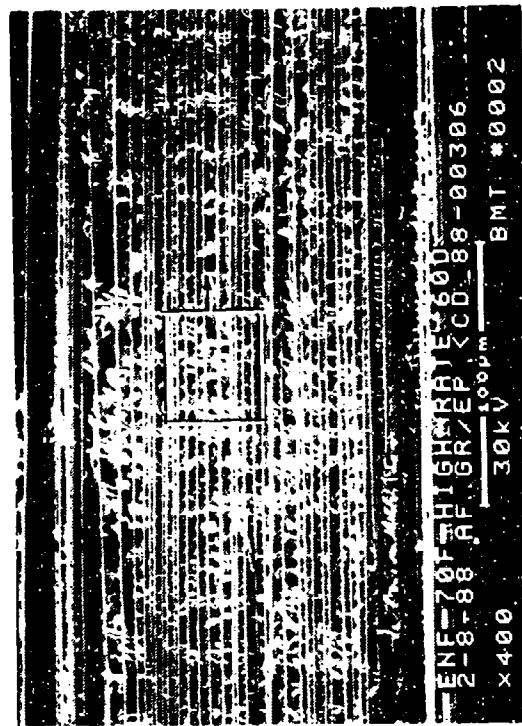
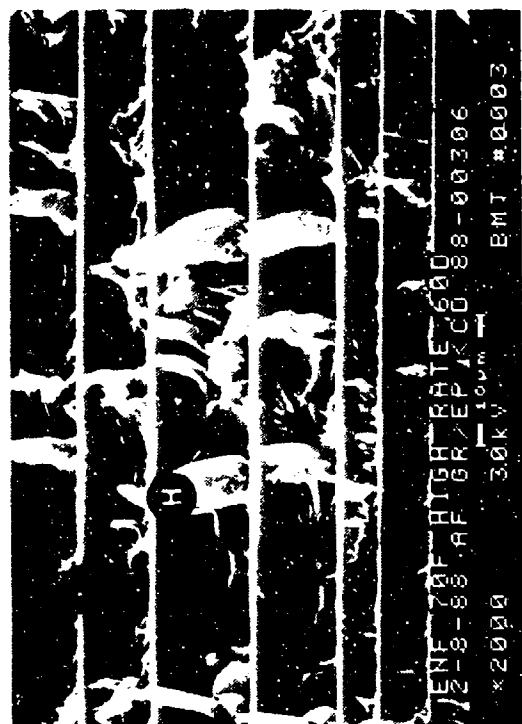
- F fiber matrix separation
- H hackle
- S scallop
- M matrix fracture

Figure 2-216. SEM Fractographs of Interlaminar Mode II Shear, Room Temperature, High Rate Fracture (Region II of Figure 2-214)

Optical microscopy of the fracture surface showed a difference between the high rate specimen and the typical ENF specimen tested at constant rate (Figure 2-214). Due to the very rapid fracture, hackles were formed in various tilts and shapes; at slower crack growth rates, the hackles tend to form parallel to one another. Regions created by initial and secondary projectile penetration (resulting in different crack growth rates) exhibited no distinctly different features (Figures 2-215 and 2-216).

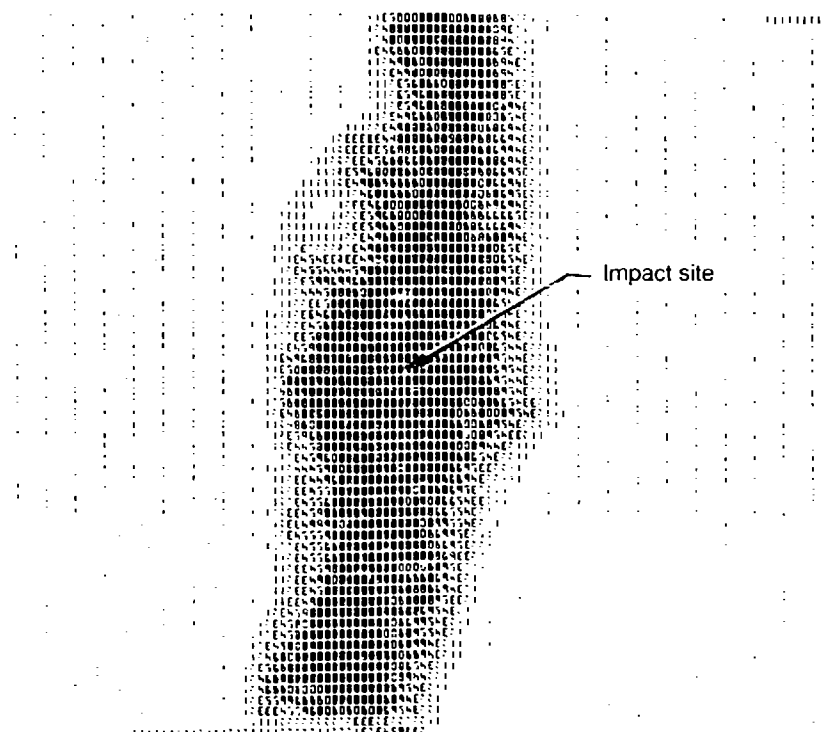
Figure 2-217. Extent of Impact Damage Identified by Through Transmission Ultrasonic (TTU) Scan of Impact Specimen

Visual inspection revealed extensive buckling damage around the point of impact. Failure of the panel occurred in a band approximately 1.0 to 1.5 inches wide across the full width of the panel (Figure 2-217). TTU indicated a delamination which was exposed for further examination to determine the mode of failure in the vicinity of the impacted area. An examination was conducted under the optical microscope. In the region immediately surrounding the impact site (0.3 inch in diameter), the features were predominantly hackle formations indicating Mode II shear failure. The outer perimeter of the impact site was predominantly covered with rivermarks and resin microflow indicating Mode I tension failure (Figure 2-218). The crack initiated at the impact site and propagated radially through the specimen from the tool side in both interlaminar and translaminar fracture modes (Figure 2-219). Figure 2-220 shows CAI fractography performed by Boeing on a [0/45/90]_{8s} laminate. Additional CAI test fractography of a [0/45/90]_{8s} Gr/Ep laminate is shown in Figure 2-170.

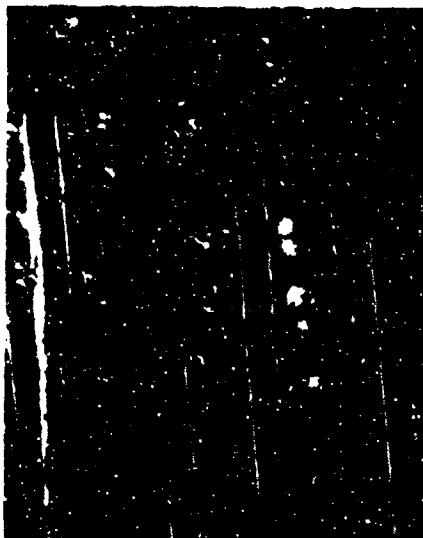
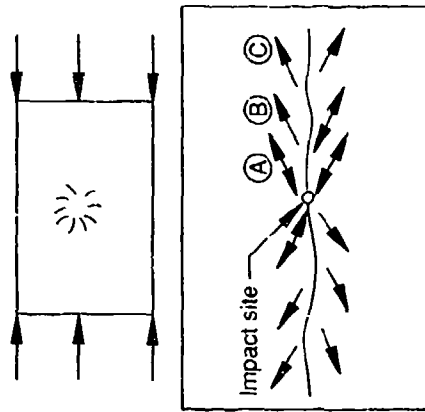
Key to crack growth
direction arrows:
→ Mode I tension
↗ ↘ Mode II shear

Figure 2-218. Optical Photomicrographs of Interlaminar Fracture of Compression-After-Impact, RT/Dry, [0/45/90/-45]_{4s} Specimen

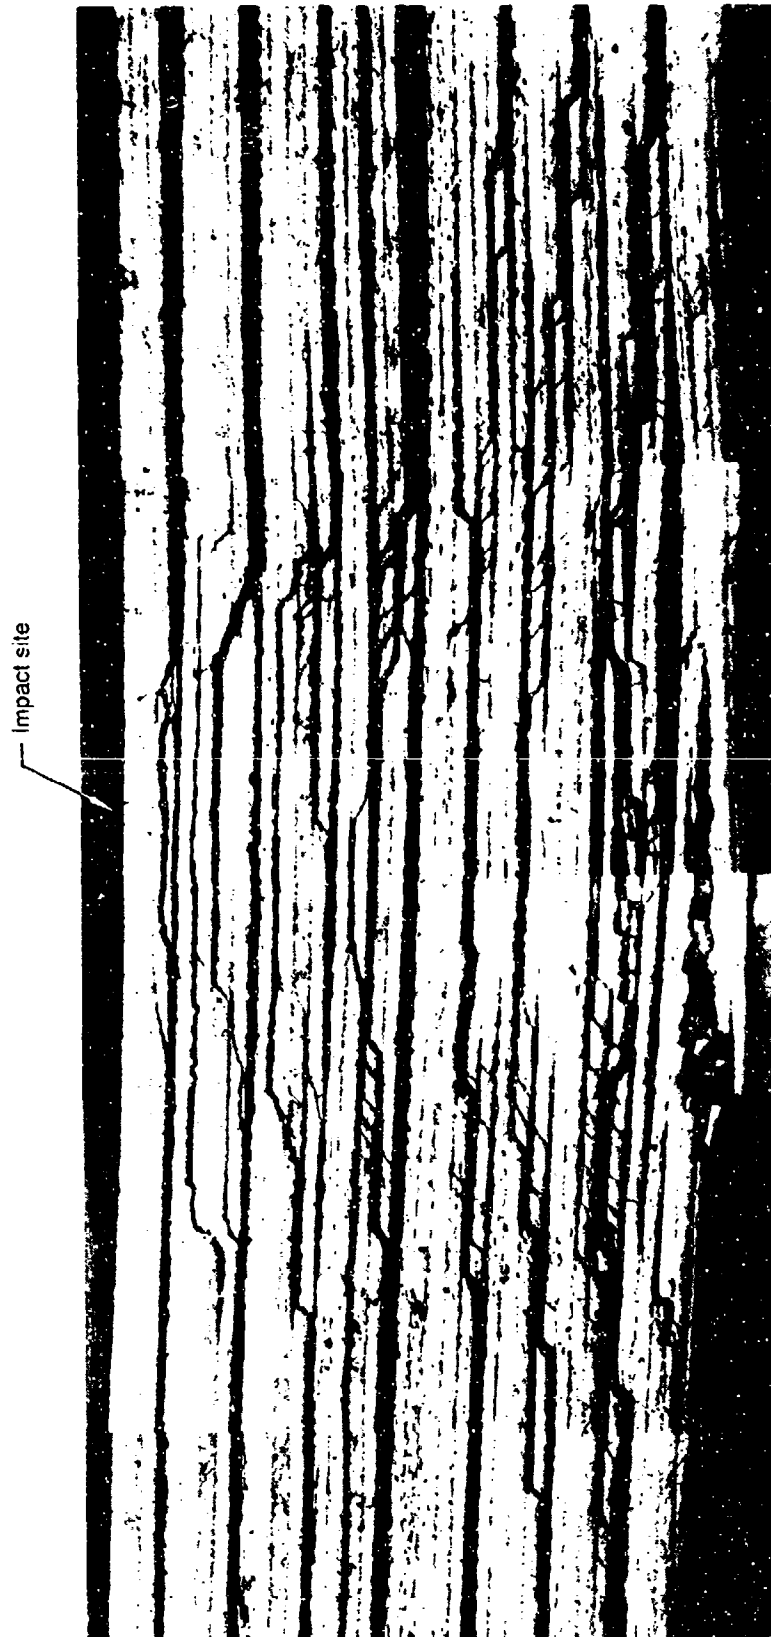
Figure 2-219. Cross-Sectional View of Compression-After-Impact, RT/Dry, [0/+45/90/-45]_s Specimen

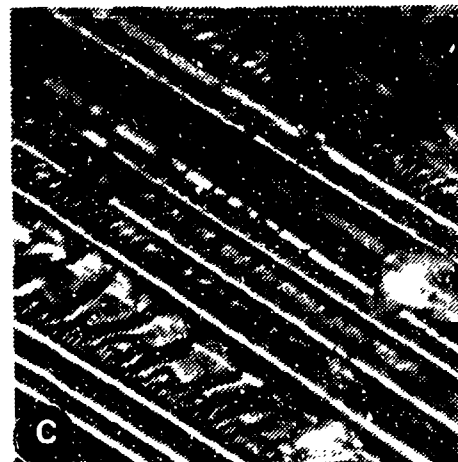
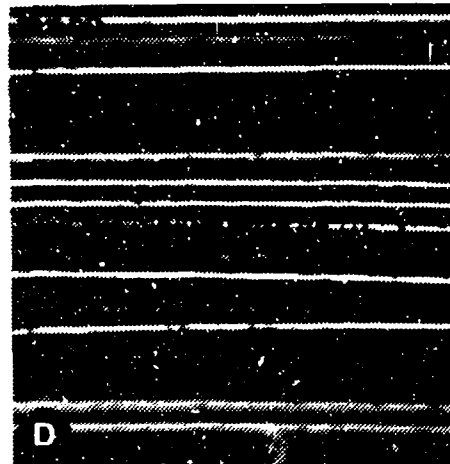
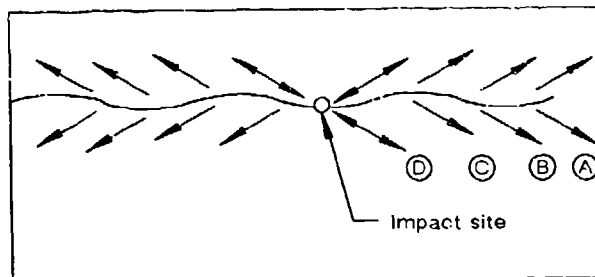
Fracture type	Interlaminar/translaminar
Ply layup	[0, 45, 90] _{8S}
Test type	Compression after impact
• Test conditions	Dry
• Fracture between	0/45/90 plies
Material	Hercules 3501-6/177°C cure AS4 fibers

Key to crack growth
direction arrows:
— Mode I tension
— Mode II shear

Figure 2-220. SEM Photographs of Interlaminar/Translaminar Compression After Impact, 0/45/90 Fracture

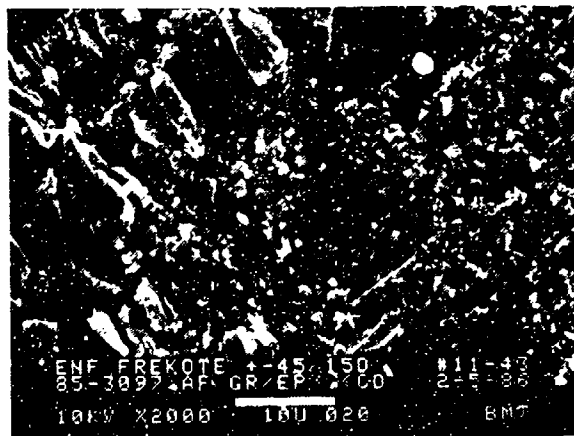
2000X
Mode II shear

Figure 2-222. SEM Photographs of Interlaminar Mode I Tension and Mode II Shear, 0/45 and 45/45 Fractures, Frekote Contamination, 70 F/Dry

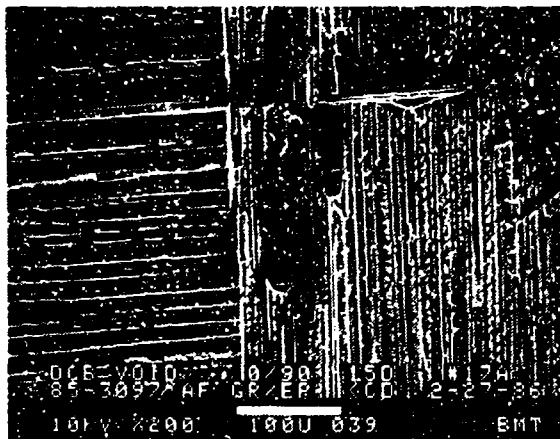
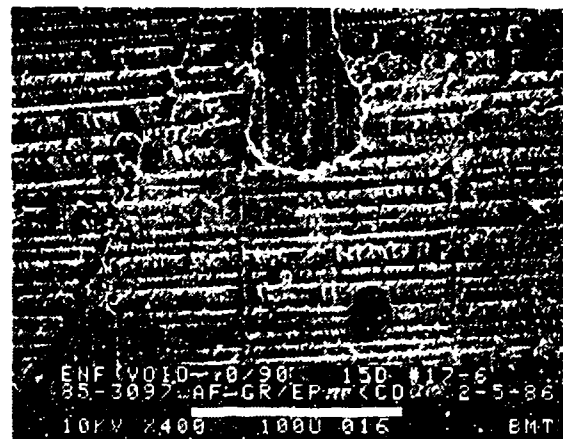
Fracture type	Interlaminar mode I tension
Ply layup	[0, 90] 12S
Test type	DCB—high void content
• Test conditions	21°C, dry
• Fracture between	0/90 plies
Material	Hercules 3501-6/177°C cure AS4 fibers

Fracture type	Interlaminar mode II shear
Ply layup	[0, 90] 12S
Test type	ENF—high void content
• Test conditions	21°C, dry
• Fracture between	0/90 plies
Material	Hercules 3501-6/177°C cure AS4 fibers

← Mechanically induced crack direction

Figure 2-223. SEM Photographs of Interlaminar Mode I Tension and Mode II Shear, 0/90 Fractures, With Voids, 70 F/Dry

The primary features observed in the void containing specimens were as follows:

1. Smooth, featureless, rounded edged surfaces
2. Underlying fibers can be seen below voids
3. Fracture surface surrounding void region, exhibiting a matrix fracture morphology typical of the induced loading mode (allows determination of crack-growth and mode).

Figure 2-223 shows microphotographs of two test types of voids, DCB and ENF. This contribution was made by Boeing.

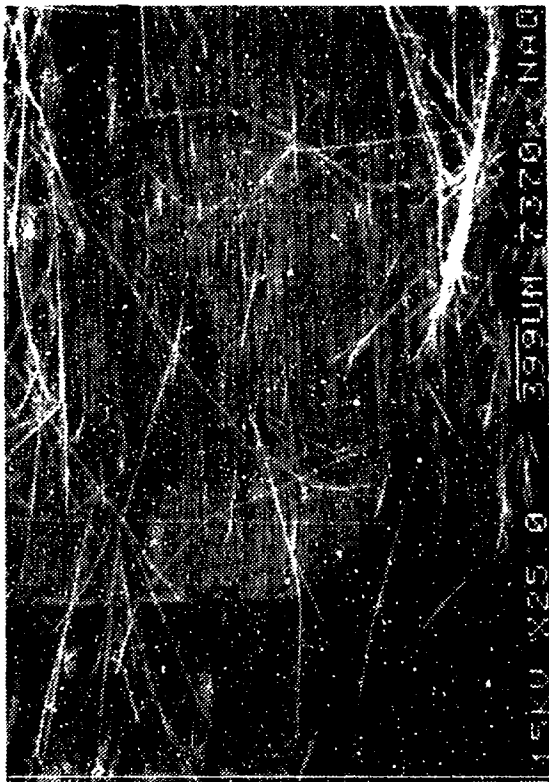
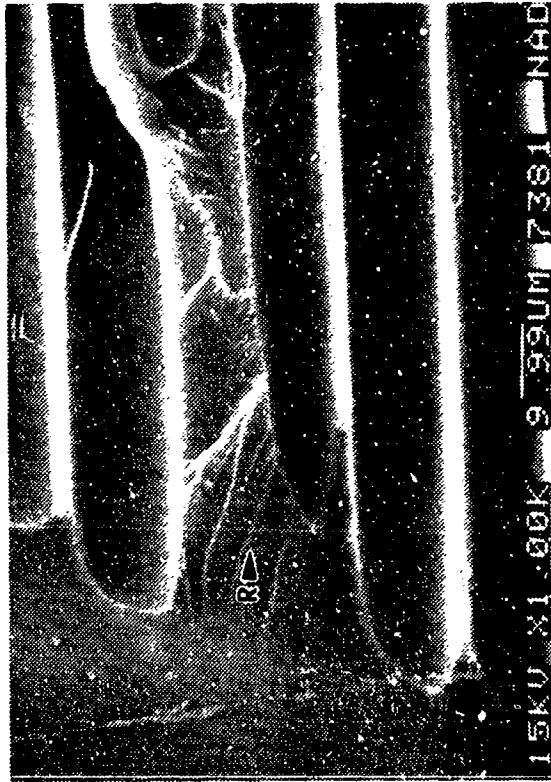
Figure 3-1. Optical and SEM Photographs of Mode I DCB Interlaminar Tension Fracture in 49/3501-6 Kevlar/Ep - [0]_{24T}, Room Temperature Ambient
 (a) Macro photograph of Fracture
 (b) Fiber Pull-Out
 (c) River Patterns (R) in Fractured Resin
 CD = Crack-propagation direction

Fractographs of 49/3501-6 Kevlar/epoxy are provided for interlaminar testing in Figures 3-1 through 3-9 and for translaminar testing in Figures 3-10 through 3-15. This contribution was made by Northrop.

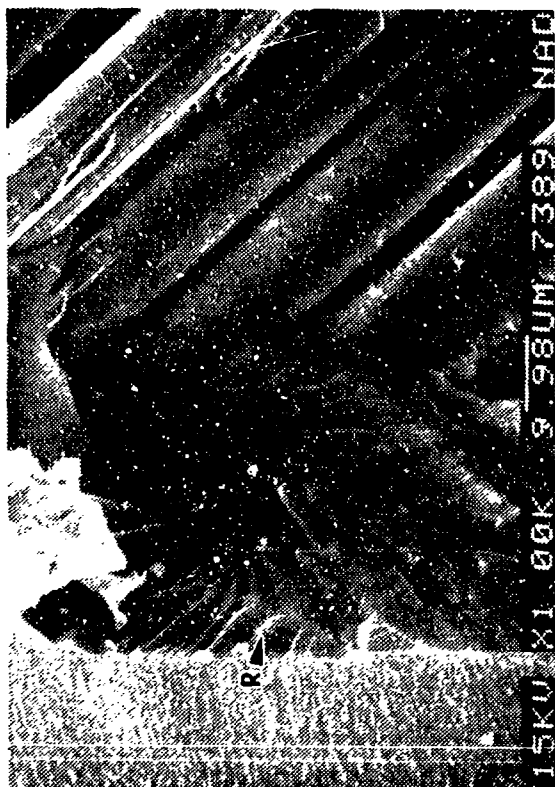
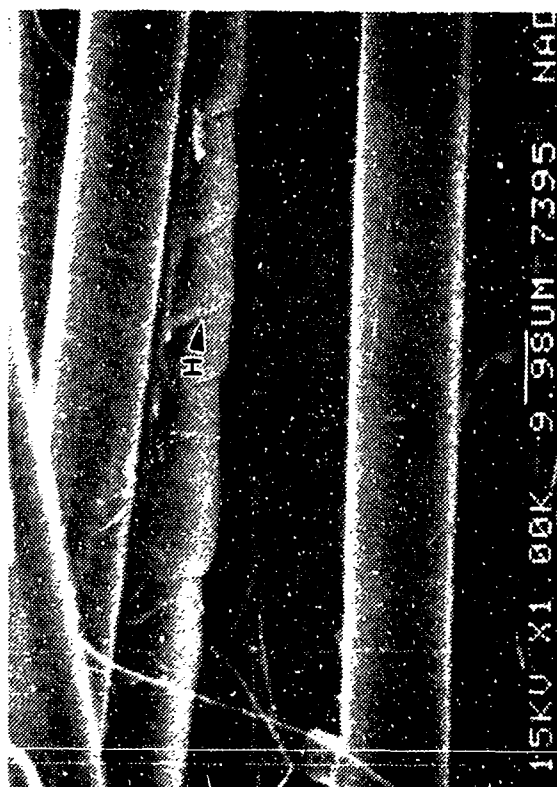
Figure 3-2. Optical and SEM Photographs of Mode I DCB Interlaminar Tension Fracture in 49/3501-6 Kevlar/Ep - [+45/0/-45]_s, Room Temperature Ambient

(a) Macro photograph of Fracture

(c) Hackles (H) in Fractured Resin

CD = Crack-propagation direction

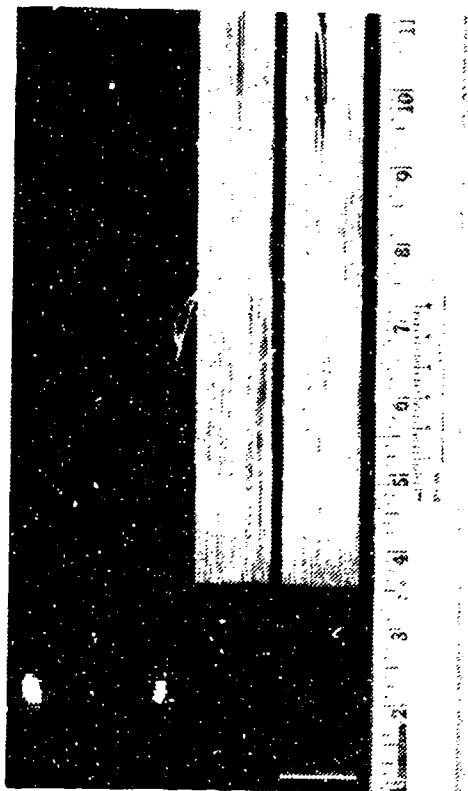
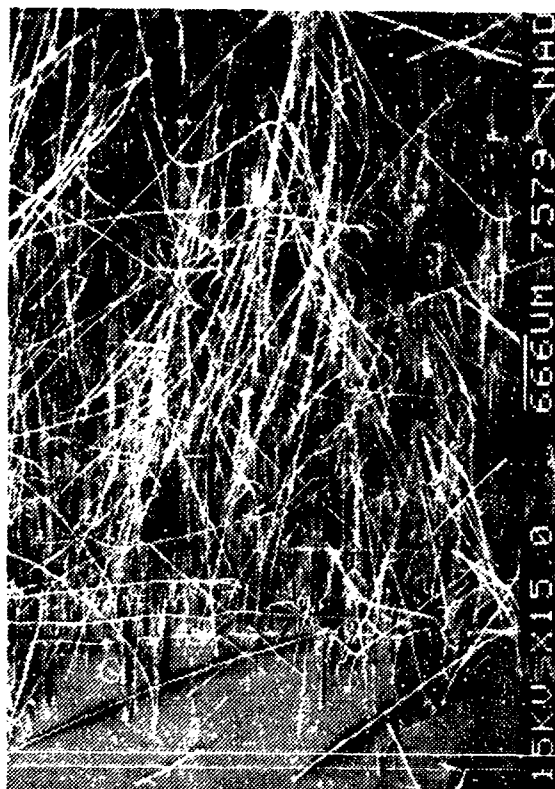
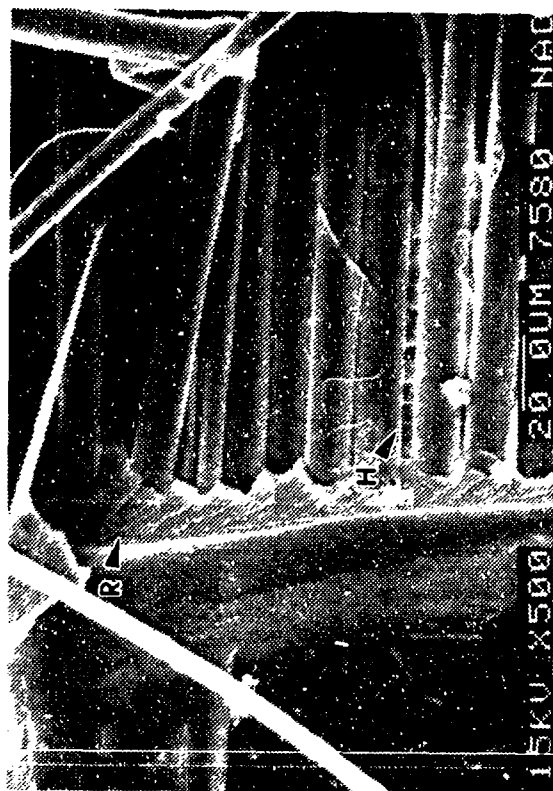
Figure 3-3. Optical and SEM Photographs of Mode I DCB Interlaminar Tension Fracture in 49/3501-6 Kevlar/Ep - [0]_{24T}, Conditioned 180 F Dry, ~ Weeks Before Test

(a) Macro photograph of Fracture

(c) River Patterns (R) and Hackles (H) in Precrack Region

CD = Crack-propagation direction

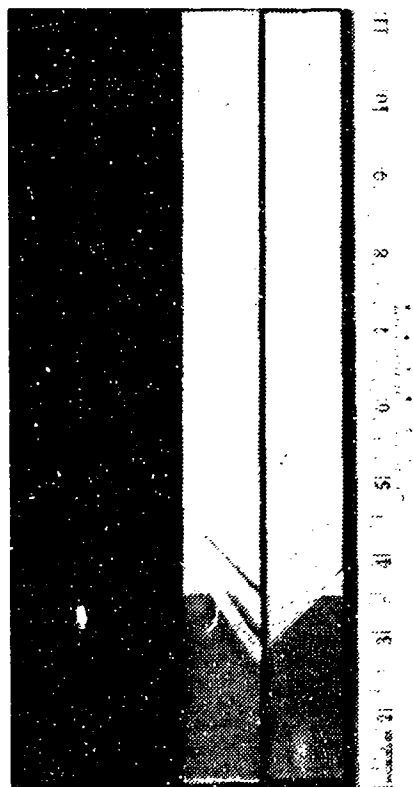
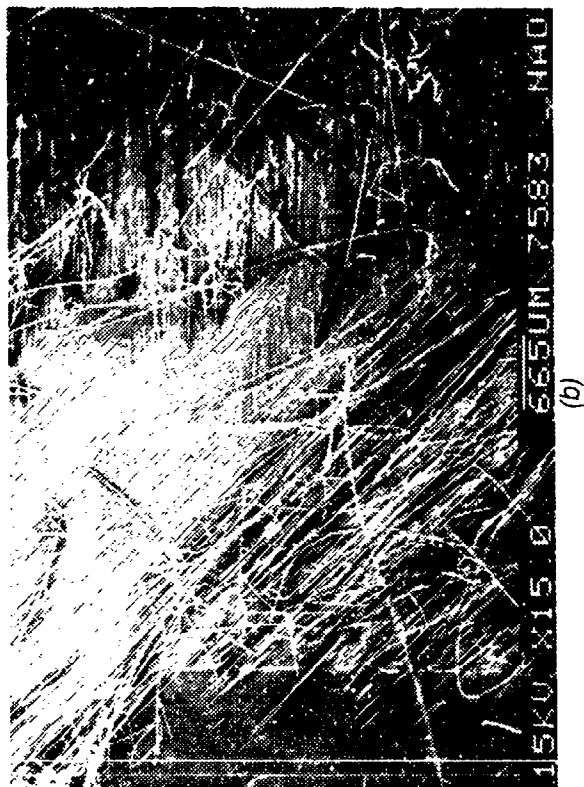
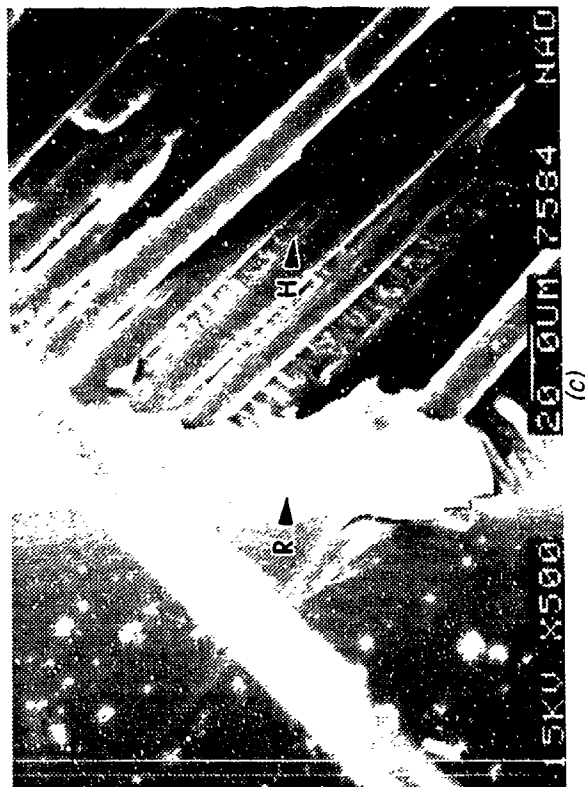
Figure 3-4. Optical and SEM Photographs of Mode I DCB Interlaminar Tension Fracture in 49/3501-6 Kevlar/Ep - [$+45/0/-45$]_{4s}, Water Immersed Before Test
 (a) Macrofracture of Fracture
 (b) Fiber Pull-Out
 (c) Rivers (R) and Hackles (H) in Fractured Resin
 CD = Crack propagation direction

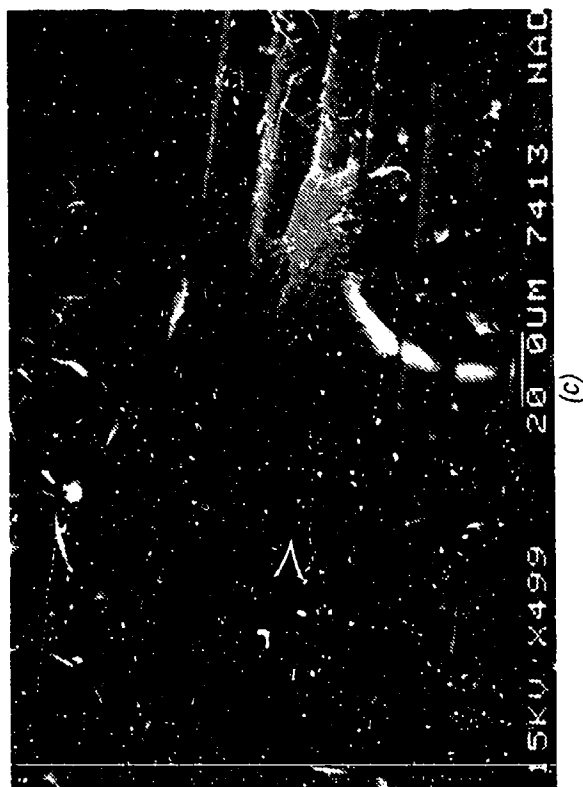
Figure 3-5. Optical and SEM Photographs of Mode II ENF Interlaminar Shear Fracture in 49/3501-6 Kevlar/Ep - [0]_{24T}, Room Temperature Ambient
(a) Macroscopic Photograph of Fracture
(b) Precrack Region Showing Fibrils
(c) River Patterns in Precrack Region (Arrow)

CD = Crack-propagation direction

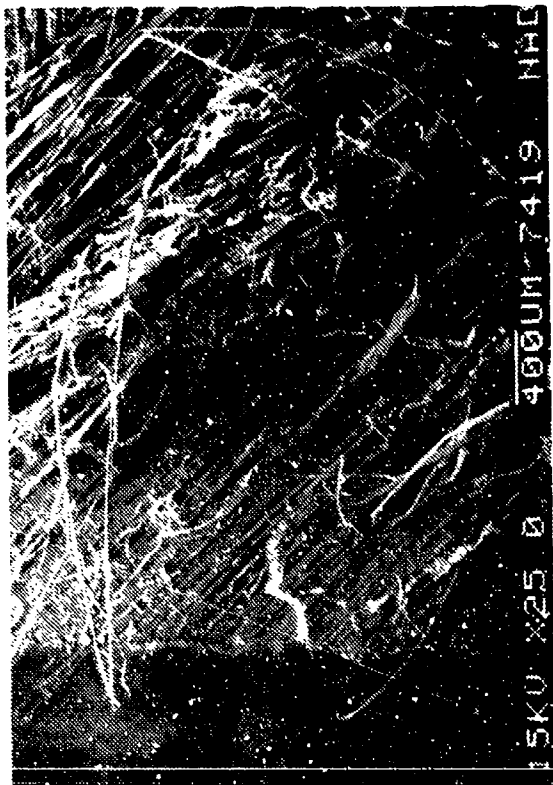
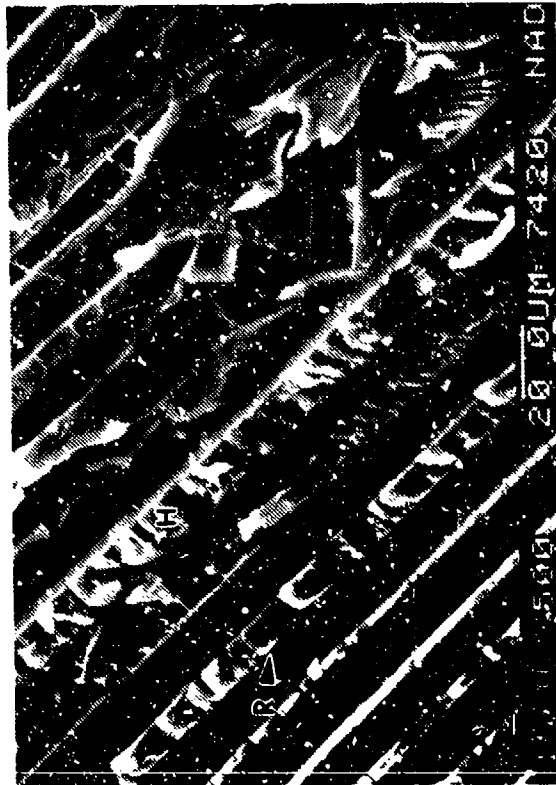
Figure 3-6. Optical and SEM Photographs of Mode II ENF Interlaminar Shear Fracture in 49/3501-6 Kevlar/Ep - [+45/0/-45]_s, Room Temperature Ambient

(a) Macrograph of Fracture

R = Rivers

C/D = Crack propagation direction

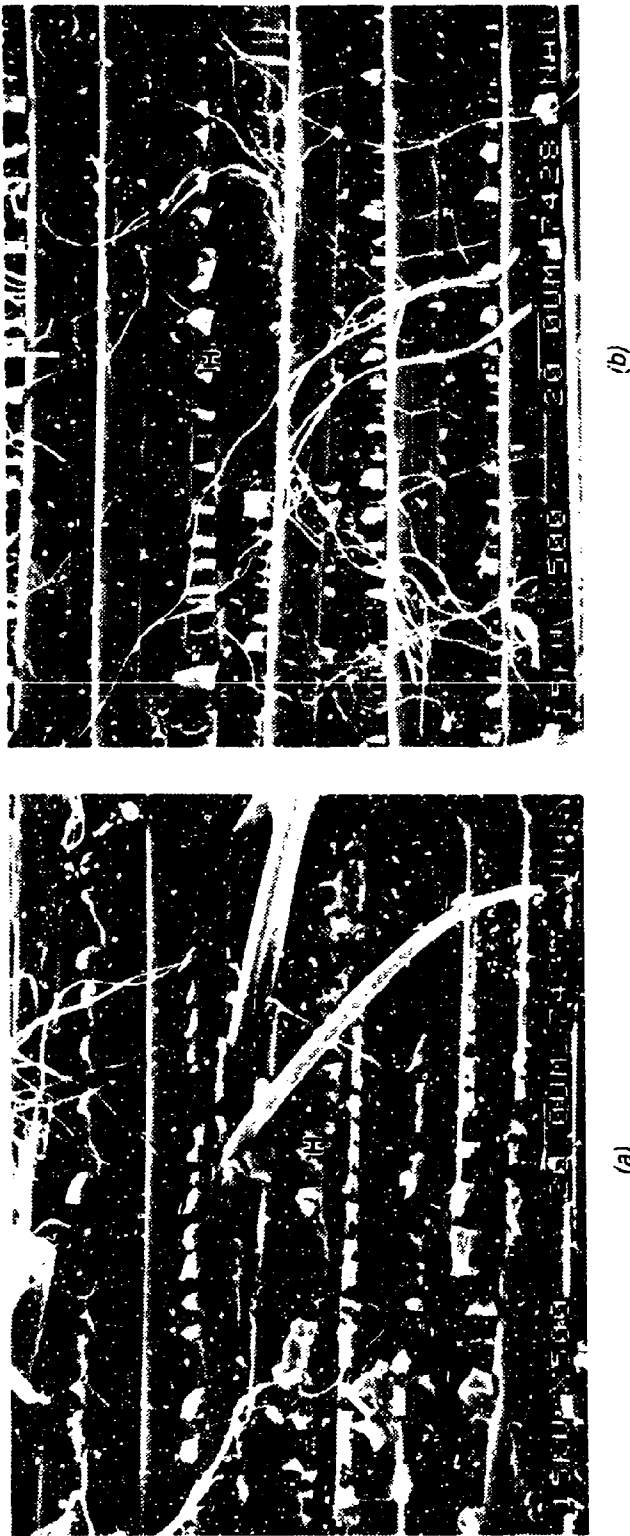
Figure 3-7. SEM Photographs of Mode II ENF Shear Crack-Growth Regions in 49/3501-6 Kevlar/Ep, Room Temperature Ambient
 (a) $[0]_{24T}$ Specimen
 (b) $[-45/0/-45]_{4S}$ Specimen
 CD = Crack-propagation direction
 H = Hackles

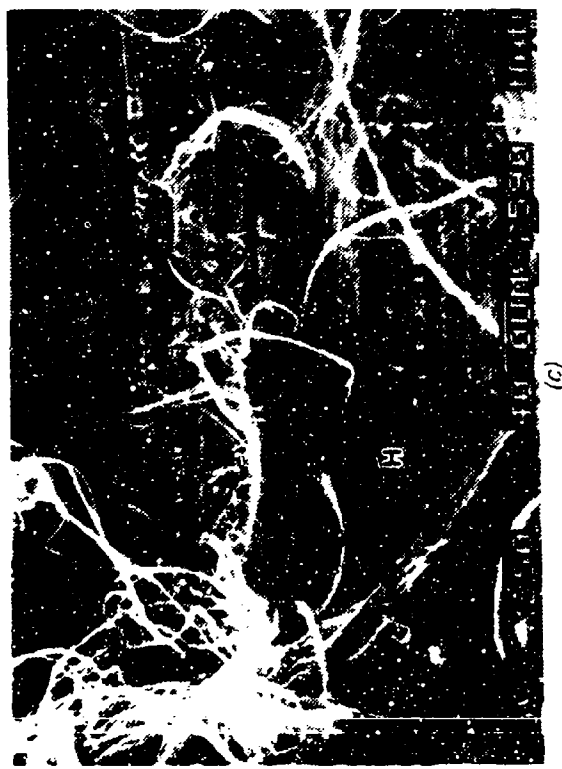
Figure 3-8. Optical and SEM Photographs of Mode II ENF Interlaminar Shear Fracture in 49/3501-6 Kevlar/Ep - [0]_{24T}. Conditioned 180 F Dry
 (a) Macrophotograph of Fracture
 (b) Precrack Region Showing Fibrils
 (c) Crack Growth Region Showing Hackles (H)

CL = Crack propagation direction

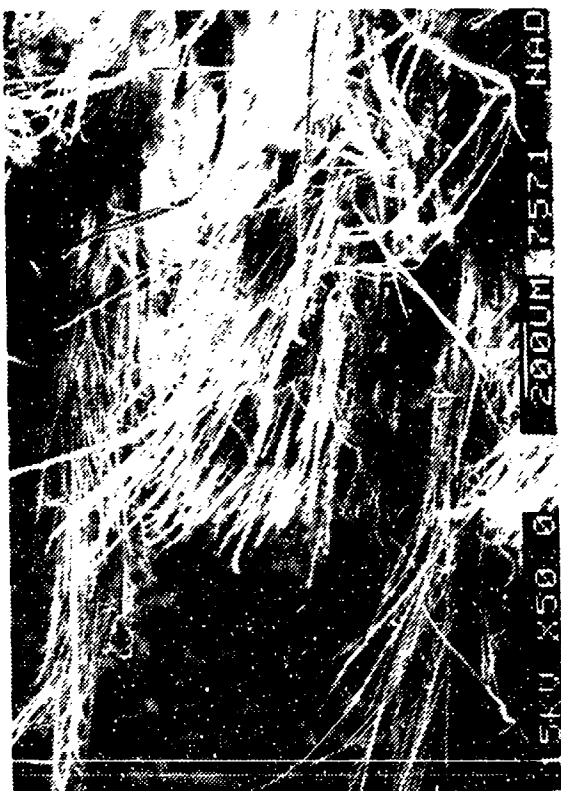
Figure 3-12. SEM Photographs of Mode I Translaminar Compression Fracture in 49/3501-6 Kevlar/Ep [90/0] as, Room Temperature Ambient

(c) Tension Fracture Region

CD = Crack propagation direction

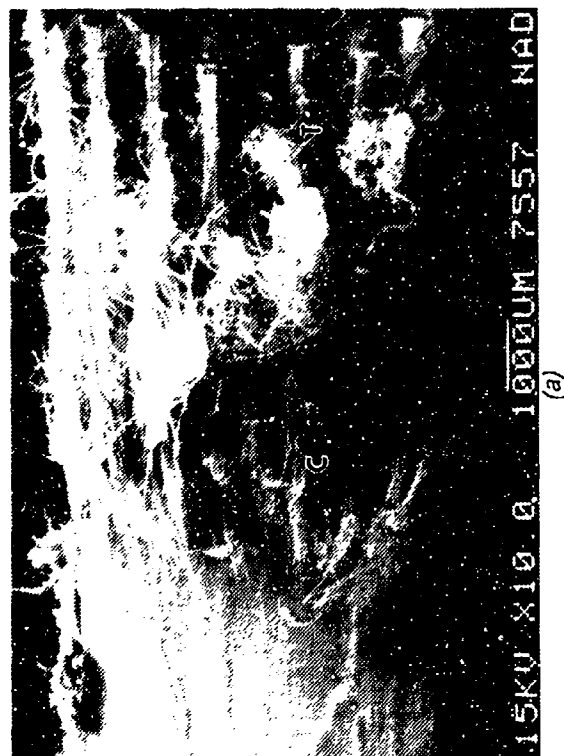
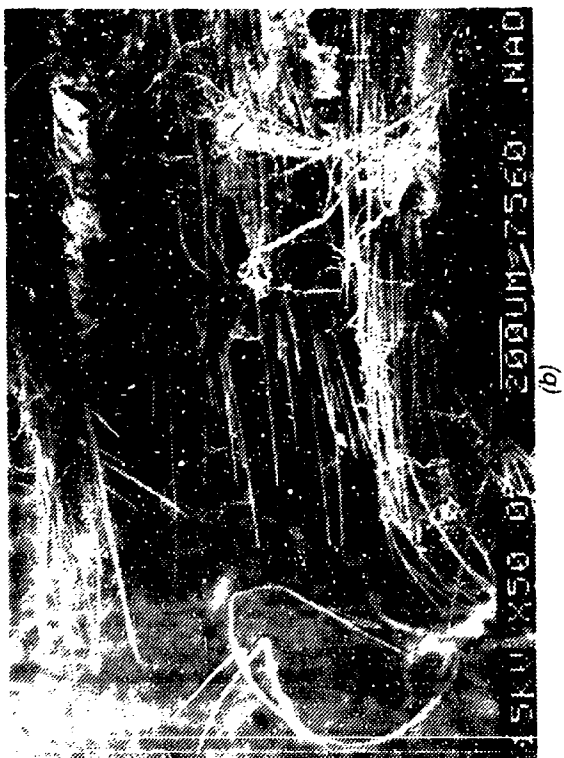
Figure 3-13. SEM Photographs of Mode I Translaminar Compression Fracture in 49/3501-6 Kevlar/Ep - 32 Ply/Quasi-Isotropic, Room Temperature Ambient

(a) Macro photograph
C = Compression region
T = Tension region

(c) Hackles (H) in Tension Fracture Region

CD = Crack-propagation direction

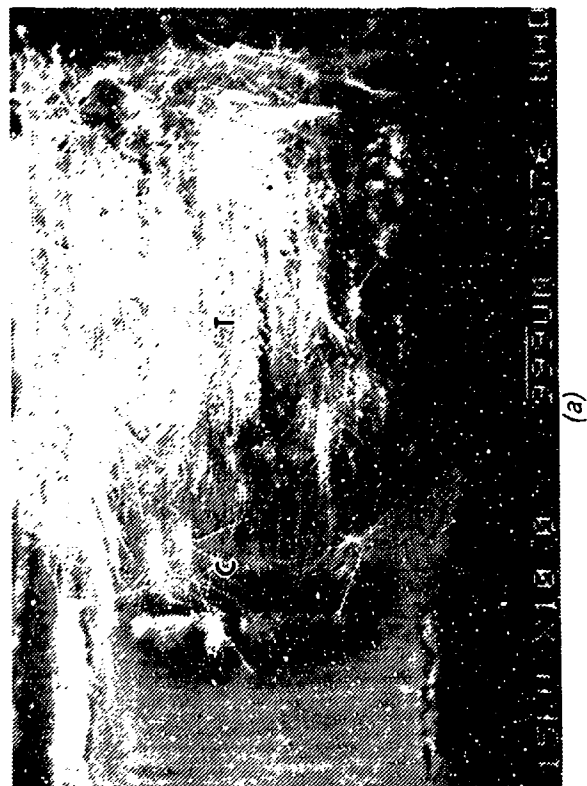
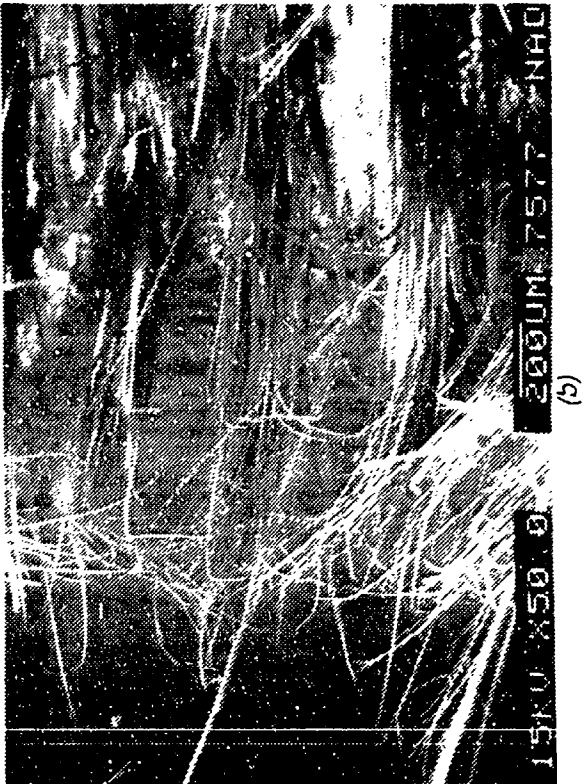
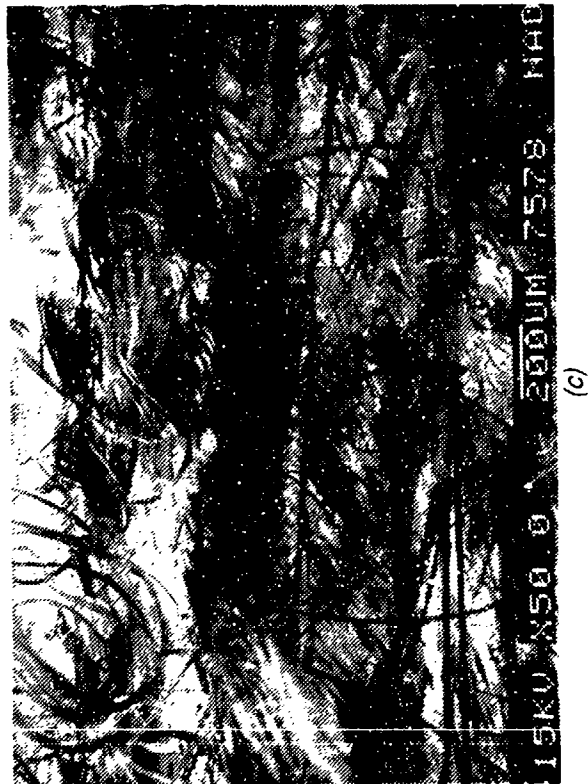
Figure 3-14. SEM Photographs of Mode I Translaminar Compression Fracture in 49/3501-6 Kevlar/Ep-[90/0]_{as}. Water Immersed Before Test
 (a) Macro photograph
 C = Compression region
 T = Tension region
 (b) Fiber Ends in Compression Region
 (c) Tension Fracture Region
 CD = Crack-propagation direction

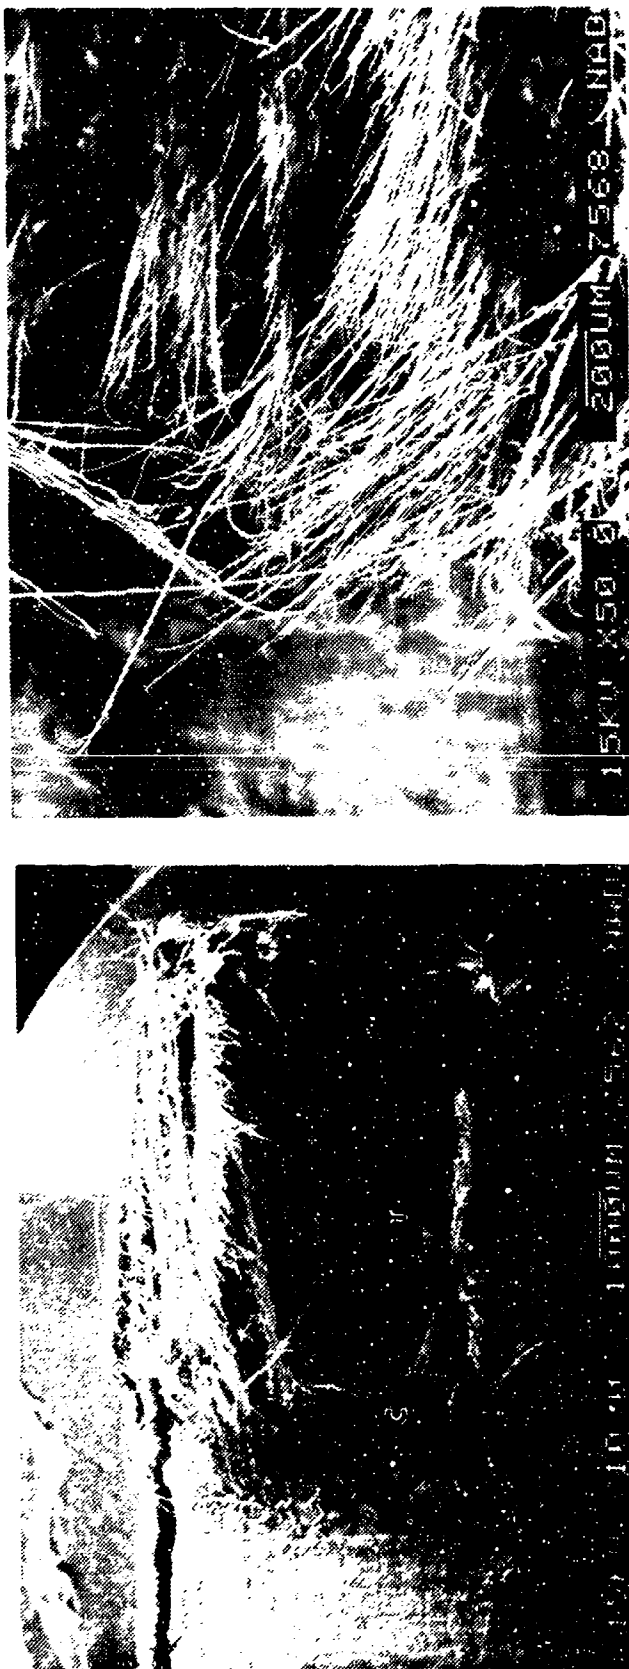
Figure 3-15. SEM Photographs of Mode I Translaminar Compression Fracture in 49/3501-6 Kevlar/Ep - 32 Ply/Quasi-Isotropic, Water Immersed Before Test

CD = Crack propagation direction

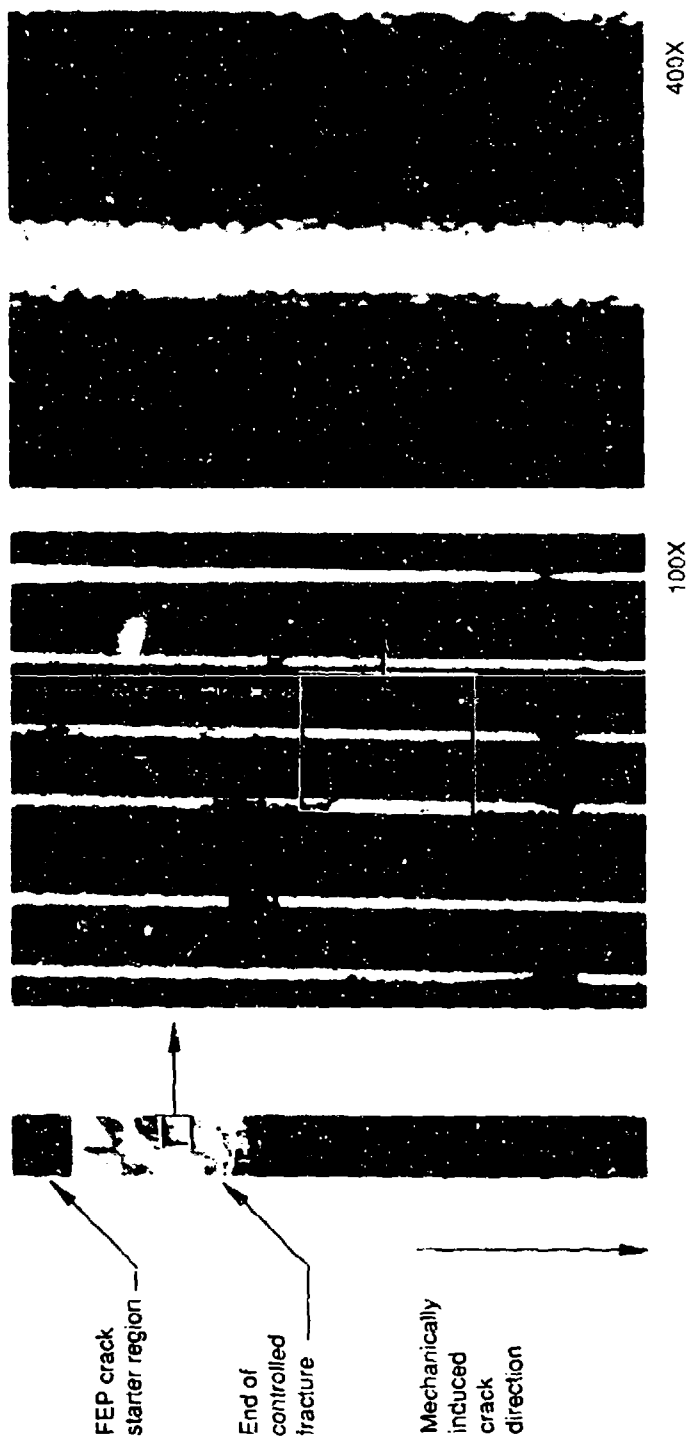
Figure 4-1. Optical Photomicrographs of Room Temperature/Dry, Interlaminar Mode I Tension, 0/90 Fracture in Boron/Epoxy

The fracture feature most frequently observed under the optical microscope was a resin flow line indicating the overall crack growth direction. This feature was similar to a river mark (Figure 4-1). The reflection of light from the boron-tungsten filament made it difficult to see some of the fine details of the critical fracture features.

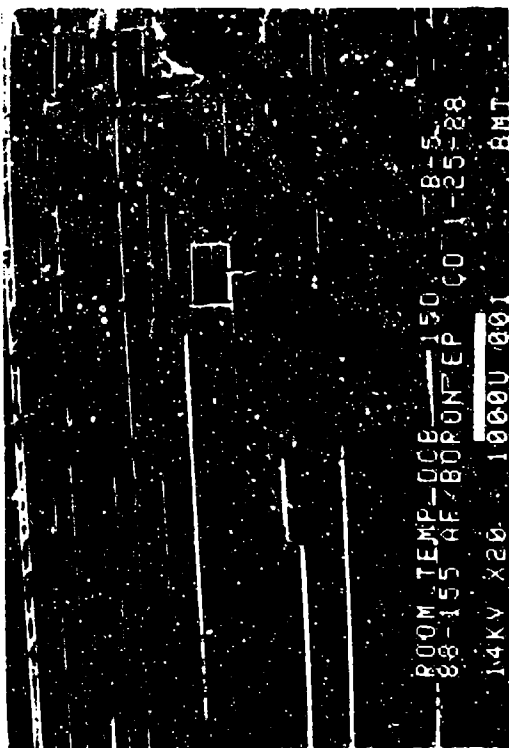
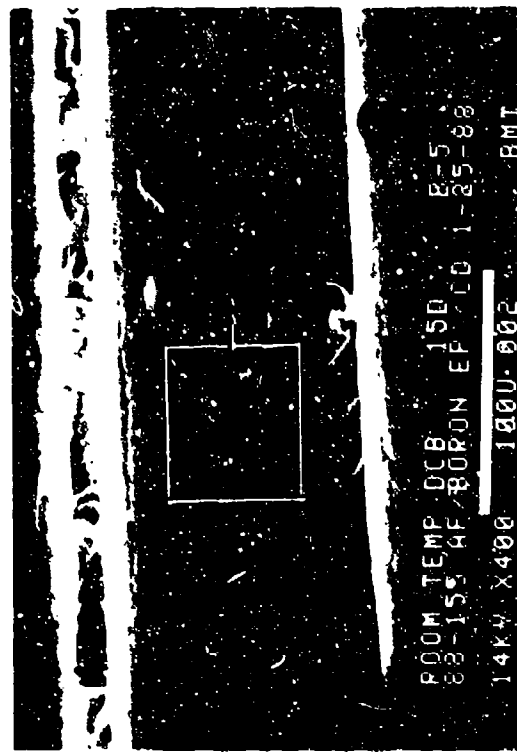
15 degree tilt

20X

B boron-tungsten filament
R rivermark

Mechanically induced
crack direction

SEM analysis showed both river marks and resin microflow lines on the fracture surface (Figure 4-2). This indicated that the crack direction could be identified from these microscopic features.

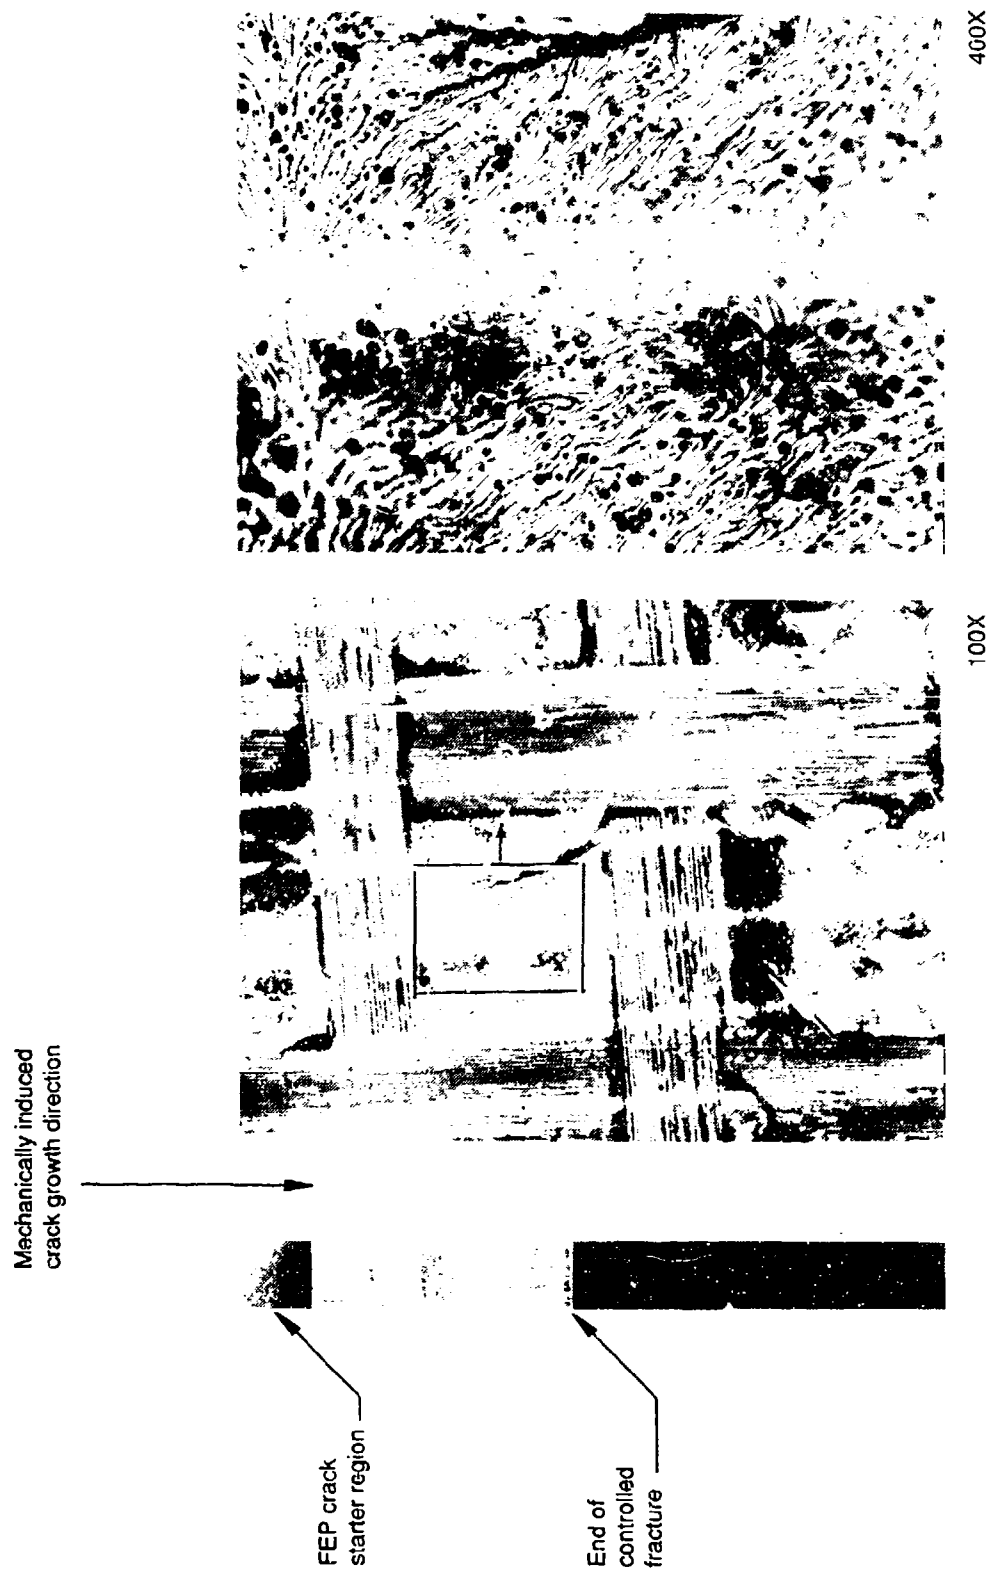
Figure 4-3. Optical Photomicrographs of 270 F/Wet, Interlaminar Mode I Tension, 0/90 Fracture in Boron/Epoxy

Visual examination revealed a fracture surface on only one or two stepped planes. This was in contrast to the RT specimen, which fractured over many stepped planes. The 270°F/wet condition made the resin ductile and prevented a multiple-plane fracture. The optical photomicrograph showed resin microflow lines similar to those observed in the RT/dry specimen (Figure 4-3).

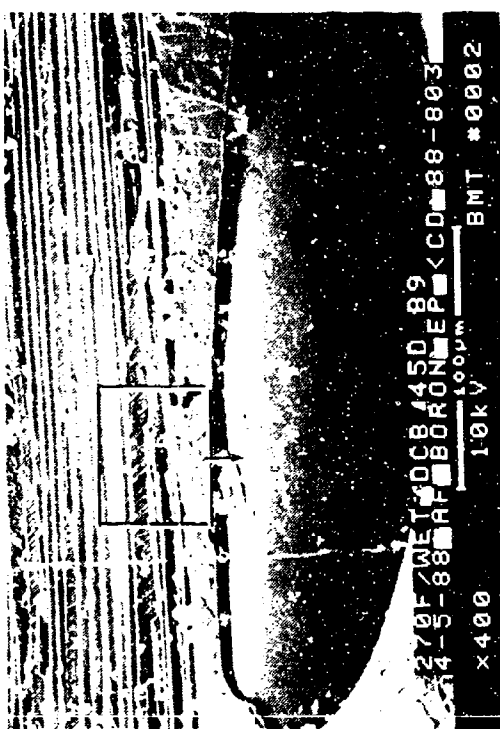
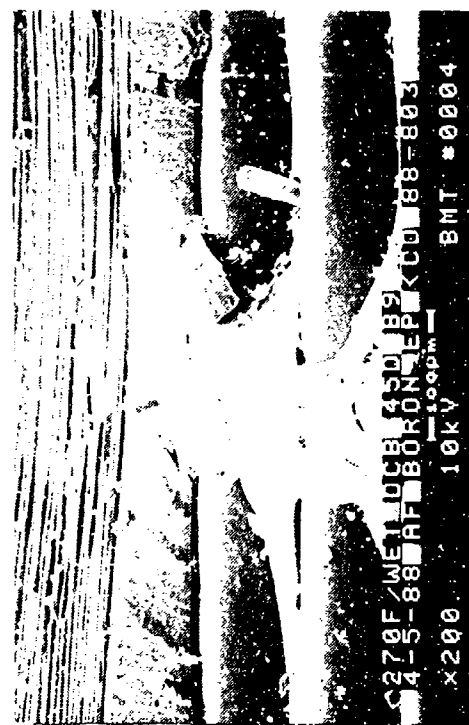
45 degree tilt (a) 20X

45 degree tilt (b) 400X

Figure 4-4. SEM Fractographs of 270 F/Wet, Interlaminar Mode I Tension, 0/90 Fracture in Boron/Epoxy

Figure 4-4 shows the SEM fractographs of the interlaminar Mode I tension specimen exposed to humidity and tested at 270°F. The fracture surface showed river marks in some regions. The major difference between the RT/dry and 270°F/wet specimens was the latter's very poor adhesion at the fiber/matrix interface.

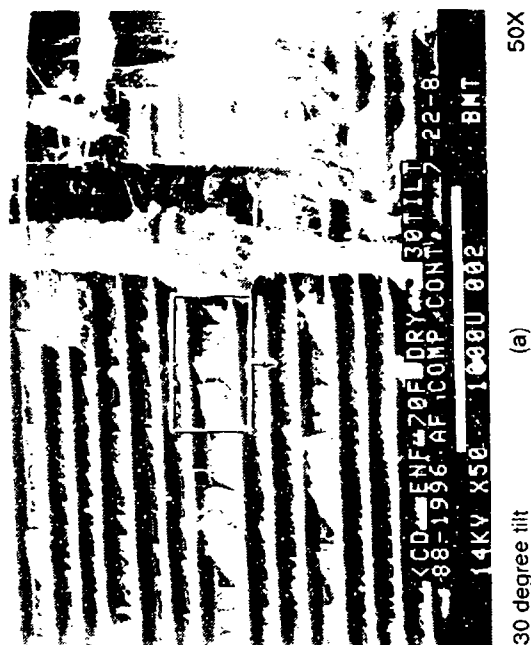
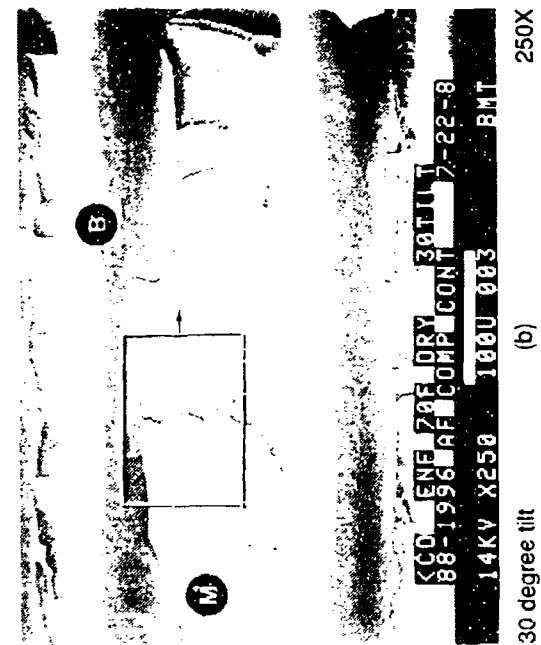
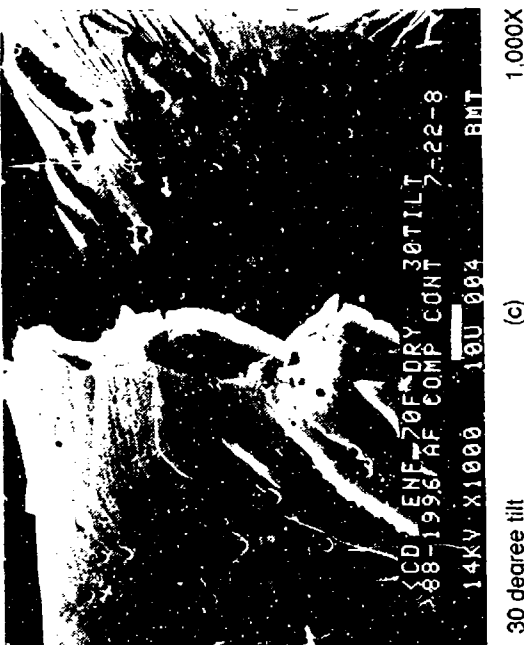
Figure 4-5. SEM Fractographs of Room Temperature/Dry, Interlaminar Mode II Shear, 0/90 Fracture in Boron/Epoxy

Under visual examination, the fracture surface was dull and milky due to the formation of hackles. This appearance was similar to that observed in previous work on the carbon-fiber reinforced epoxy system. Due to difficulties in creating a large area of interlaminar Mode II shear fracture surface for this material system, we were unable to provide a macrophotograph of the specimen. However, SEM analysis was performed on the available specimen. The fracture feature revealed resembled the hackles typically observed in the model material system, AS4/3501-6 (Figure 4-5).
